In Situ Vitrification at the Parsons Chemical/ETM Enterprises Superfund Site, Grand Ledge, Michigan

COST AND PERFORMANCE REPORT

This report presents cost and performance data for an in situ vitrification (ISV) treatment application at the Parsons Chemical/ETM Enterprises Superfund Site (Parsons) in Grand Ledge, Michigan. The Parsons site is a former agricultural chemicals mixing, manufacturing, and packaging facility. Soils and sediments at the Parsons site were contaminated with pesticides, heavy metals, and dioxins.

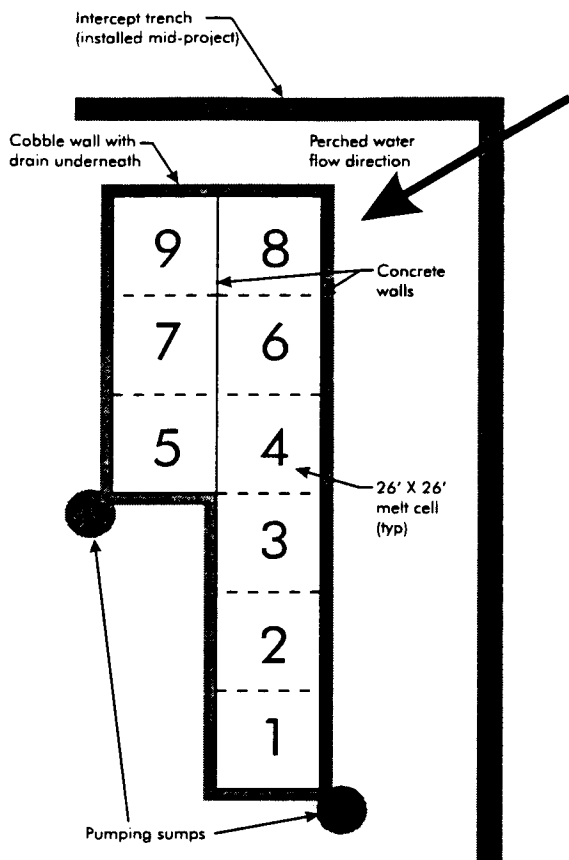
Figure 2. Plan View of Treatment Cells [25]

The ISV system used at Parsons consisted of 9 melt cells, as shown in Figure 2, an air emissions control system, and associated equipment. The melt cells were installed in a 16-foot deep treatment trench; each cell was 26 feet by 26 feet square. The trench was designed with a cobble wall and drain system to direct perched water that flowed into the site around the melt cells. [25]

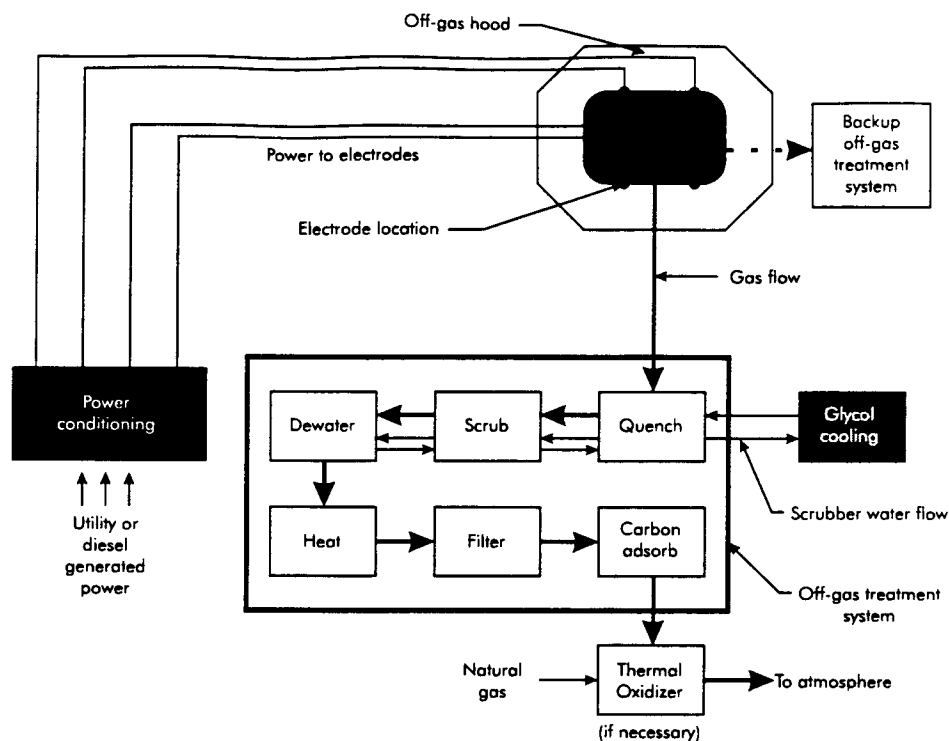
Figure 3. Geosafe In Situ Vitrification Process [41]

"The ISV Technology [used at Parsons] operates by means of four graphite electrodes, arranged in a square and inserted a short distance into the soil to be treated. A schematic of the Geosafe process is presented in Figure 3.

ISV uses electrical current to heat (melt) and vitrify the treatment material in place. A pattern of electrically conductive graphite containing glass frit is placed on the soil in paths between the electrodes. When power is fed to the electrodes, the graphite and glass frit conducts the current through the soil, heating the surrounding area and melting directly adjacent soil.

Molten soils are electrically conductive and can continue to carry the current which heats and melts soil downward and outward. The electrodes are allowed to progress down into the soil as it becomes molten, continuing the melting process to the desired treatment depth. One setting of four electrodes is referred to as a "melt." Performance of each melt occurs at an average rate of approximately three to four tons/hr.

When all of the soil within a treatment setting becomes molten, the power to the electrodes is discontinued and the molten mass begins to cool. The electrodes are cut near the surface and allowed to settle into the molten soil to become part of the melt. Inorganic contaminants in the soil are generally incorporated into the molten soil which solidifies into a monolithic vitrified mass similar in characteristics to volcanic obsidian. The vitrified soil is dense and hard, and significantly reduces the possibility of leaching from the mass over the long term.

The organic contaminants in the soil undergoing treatment are pyrolyzed (heated to decomposition temperature without oxygen) and are generally reduced to simple gases. The gases move to the surface through the dry zone immediately adjacent to the melt, and through the melt itself. Gases at the surface are collected under a stainless steel hood placed over the treatment area and then treated in an off-gas treatment system. The off-gas treatment system comprises a quencher, a scrubber, a demister, high efficiency particulate air (HEPA) filters, and activated carbon adsorption to process the off-gas before releasing the cleaned gas through a stack. A thermal oxidizer can be used following the off-gas treatment system to polish the off-gas before release to the atmosphere. A thermal oxidizer was utilized during the SITE Demonstration at the Parsons site."

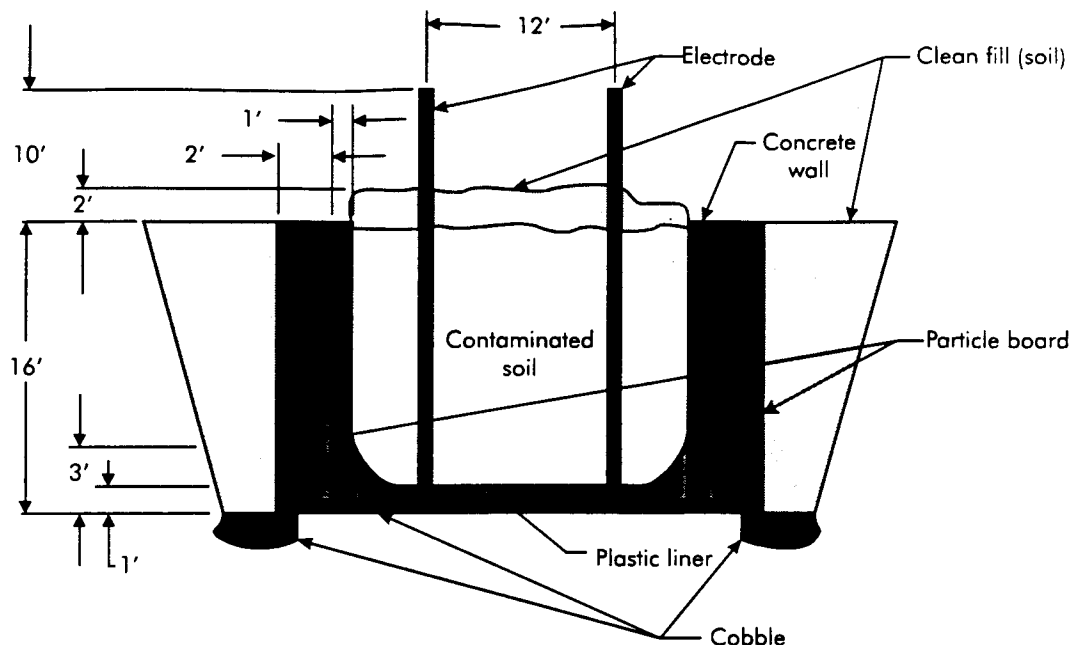
Figure 4. Side View of Typical ISV Treatment Cell [41]

"At the Parsons site, the original soil contamination was relatively shallow, five feet or less, and located in three main areas. To increase the economic viability of treatment at this site, the contaminated soil was excavated and consolidated into a series of nine treatment cells. The cell walls were built using concrete, cobble, and particle board as shown in Figure 4. The cells were constructed by trenching an area of the site, installing particle board and concrete forms, and pouring concrete into the forms to create the nine cell settings. A one-foot layer of cobble was placed in the bottom of each cell, and approximately two feet of cobble was used to surround the exterior of the cell forms. The use of cobble at the sides was intended as a means to retard melting out into adjacent clean soil. The bottom cobble was used to provide a drainage pathway for water that was known to be present on-site; the resultant flow of water was directed to a drainage trench. After construction, the cells were filled with contaminated soil from the site, and topped with a layer of clean soil.

During the treatment of the first few cells, problems with the cell design were observed. The intense heat that was melting the soil was also thermally decomposing the particle board forms. Analysis of water samples collected from the diversion system surrounding the cells identified volatiles (benzene), phenolics, and epoxies that were released by this decomposition. The cobble outside of the cells created porous paths in the vicinity of treatment, thereby increasing the likelihood of vapors escaping the area outside the hood and causing irregular melt shapes.

Geosafe responded by excavating the area outside of the remaining treatment cells and removing the particle board forms. A refractory ceramic material with insulating and reflective properties was placed adjacent to the exterior of the concrete cell walls. This helped to control the melt shape, limit fugitive vapor emissions, and restrict the melt energy inside the cell boundaries. . . . It should be noted that the use of cobble in treatment cell construction was unique to the Parsons site where the configuration and flow of the on-site groundwater dictated its application.
